Instruction Manual

Installation Instructions for:
Crank Angle Sensor replacement for EMS P/N 30-6620
1990-1995 Nissan 300ZX VG30DE, VG30DETT
1989-1998 Nissan Skyline RB26DETT,
1993-1998 Skyline RB25DET,
1989-1994 Skyline RB20DET,
1988-1990 S13 180SX, 200SX and Silvia CA18DET

**Cam / Crank Angle Sensor: AEM trigger disc MUST be used

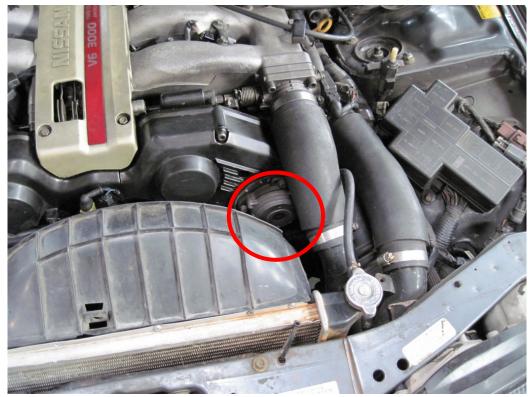
Figure 1: Location of the CAS sensor

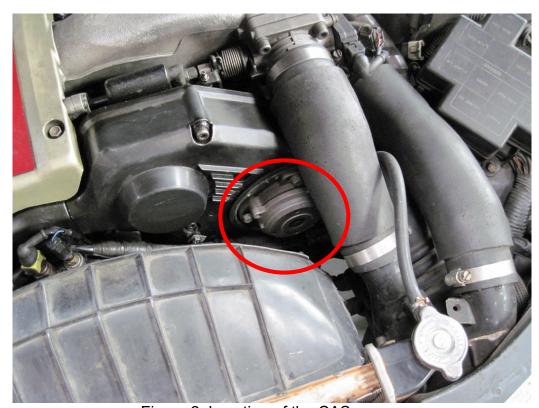
Figure 2: Location of the CAS sensor

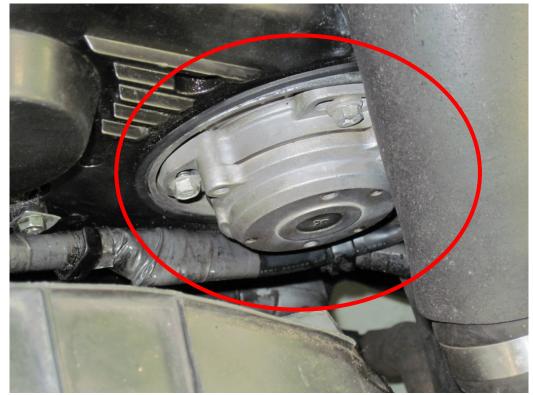
Figure 3: Close-up of CAS sensor

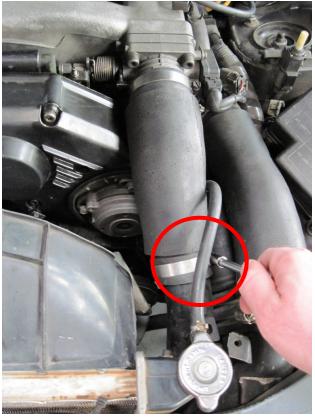
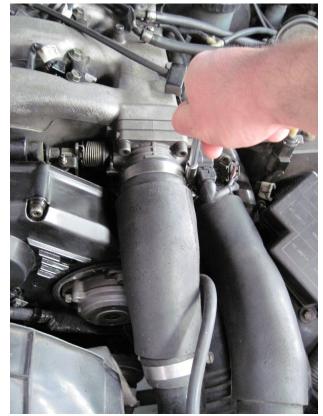
Figure 4: Removal of intake tube using 8mm socket

Figure 5: Removal of intake tube using 8mm socket

Remove intake tube obstructing access to the CAS sensor using an 8mm socket as shown in figures 4 and 5. Figure 6 shows how access to the CAS sensor looks once the tube is removed.

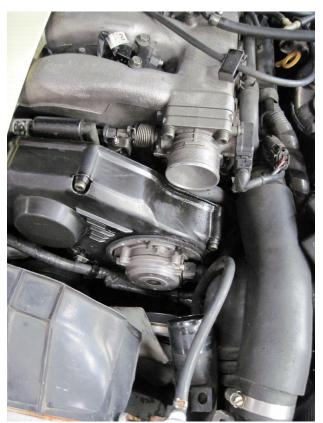
Figure 6: Intake tube removed to access CAS sensor

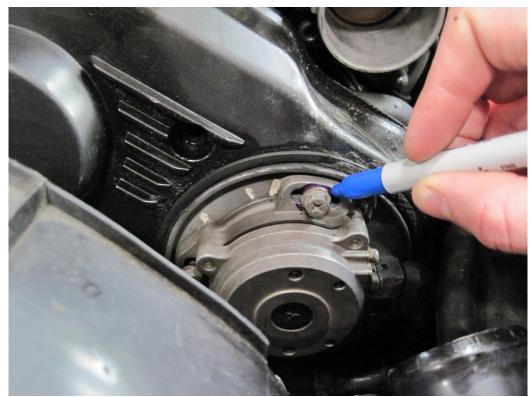
Figure 7: Marking position of CAS sensor

Figure 8: Marking position of CAS sensor

Mark the three bolts on the CAS sensor with your Sharpie as shown in figures 7 and 8 so that the sensor will go back into its original position upon reinstallation.

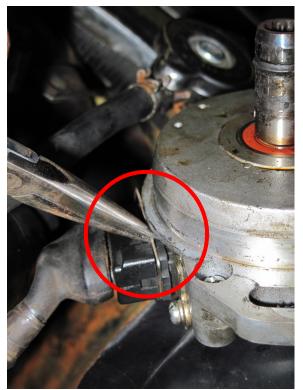
Figure 9: Pry here to remove this clip

Figure 10: Remove clip with needle-nose pliers

Remove clip that holds the harness to the CAS sensor using a pick and a pair of needle-nose pliers as shown in figures 9 and 10. This may be done after removing the CAS assembly, <u>but is best done now.</u>

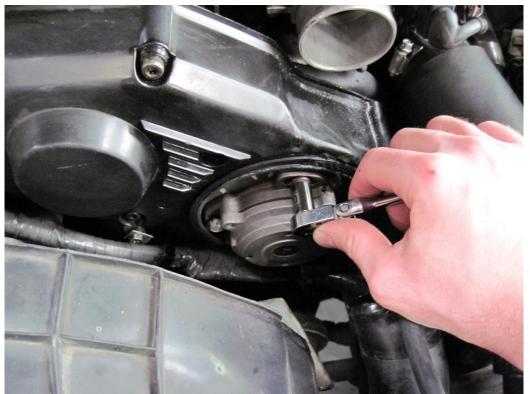
Figure 11: Removal of 3 CAS sensor bolts using 10mm socket

Remove the three bolts on the CAS sensor using a 10mm socket as shown in figure 11. Take care not to turn the sensor. Mark with your Sharpie so that the sensor can be reinstalled correctly as shown in figure 12. Figure 13 shows the cam with the CAS assembly removed. (If you turn the sensor by accident, make sure to align it with cam and

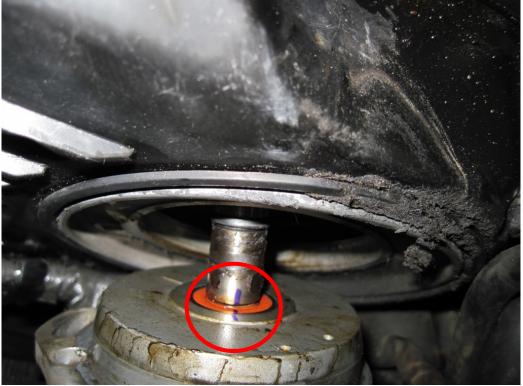
Figure 12: Mark shaft relative to housing for correct reinstallation onto cam Page 8 of 25

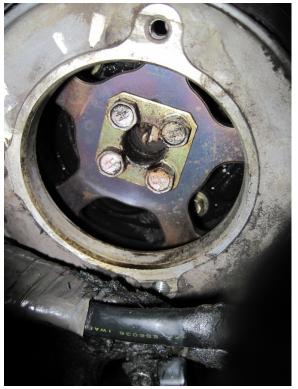
Figure 13: CAS sensor removed

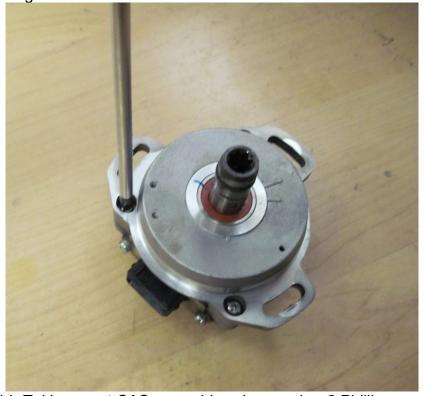
Figure 14: Taking apart CAS assembly using number 2 Phillips screwdriver

Remove the three screws holding the CAS assembly together using a $\frac{1}{4}$ " flat screwdriver (use the flat screwdriver since these screws are tightly installed, but soft) as shown in figure 14.

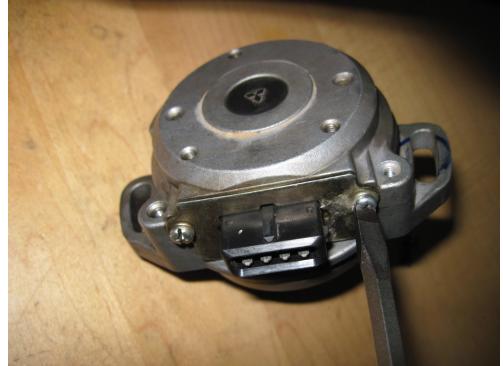
Figure 15: Removing seal cover on CAS assembly using 1/4" screwdriver

Remove screws holding the seal cover onto the assembly using a ½" flat screwdriver

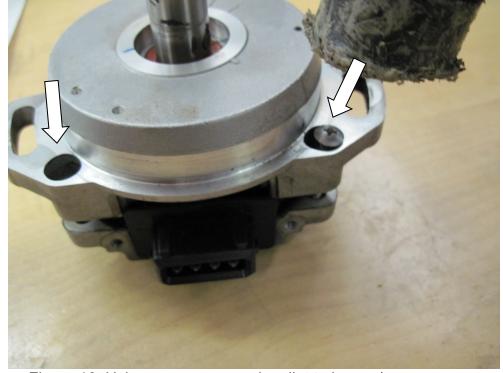
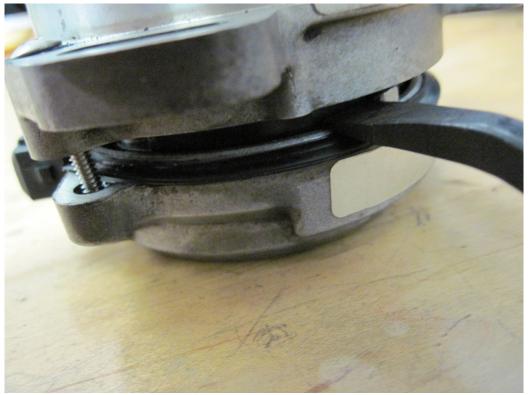
Figure 16: Using cap screws and mallet to loosen/remove cover

Figure 17: Using prybar to remove cover

Screw in the M4x45mm cap screws so that plenty of threads are engaged and lightly tap the three bolts evenly using a mallet so that the assembly will separate as shown in figure 16. If prying between the two halves is necessary as shown in figure 17, be

extremely careful not to damage the sensor inside or the rubber seal.

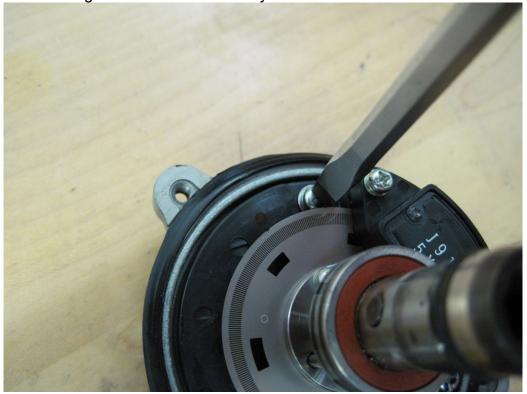
Figure 18: Remove 3 screws holding sensor using 1/4" flat screwdriver

Figure 19: Remove seal from CAS assembly

Remove the 3 screws holding the CAS sensor onto the assembly as shown in figure 18 as well as the rubber seal shown in figure 19. Make sure that you do not remove the screws in figure 20 because this may render the CAS sensor useless.

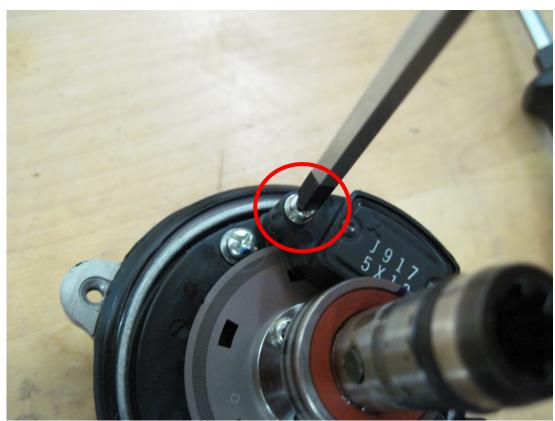
Figure 20: DO NOT REMOVE THESE SCREWS!

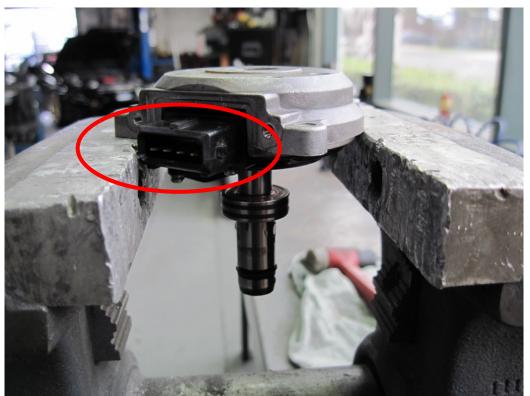
Figure 21: Mounting CAS assembly in vise to separate from shaft

Figure 22: Mounting CAS assembly in vise to separate from shaft

Mount the assembly in a vise placing the two ears that stick out of the cover shown in figure 21 on the jaws being mindful of the plastic connector to the CAS sensor as

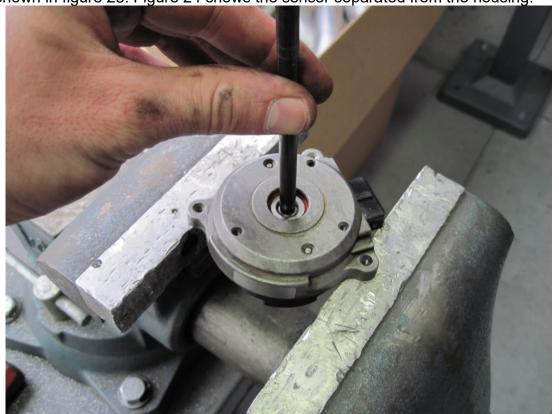
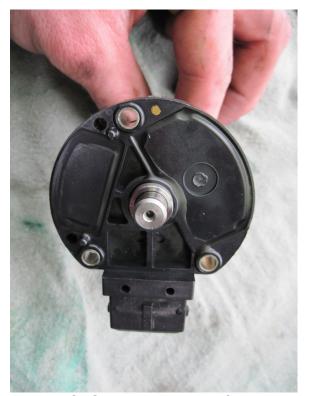
Figure 23: Separation of shaft from housing using 3/8" pin punch and hammer

Figure 24: CAS sensor removed from housing

Remove the shaft from the remaining half of the housing using a 3/8" pin punch as shown in figure 23. Figure 24 shows the sensor separated from the housing.

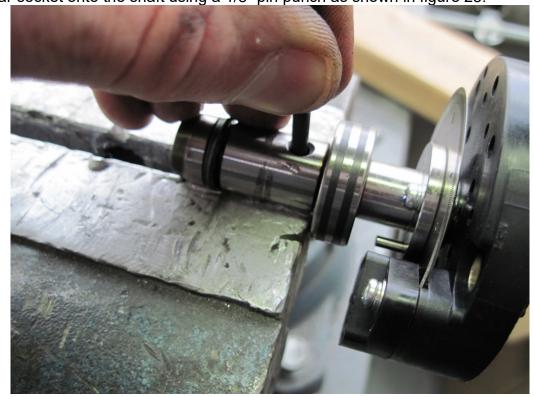
Figure 25: Removal of pin using 1/8" pin punch

This step requires a lot of finesse or help from a friend to hold the shaft from falling off the vise. Mark the star socket relative to the shaft and remove the pin holding the star socket onto the shaft using a 1/8" pin punch as shown in figure 25.

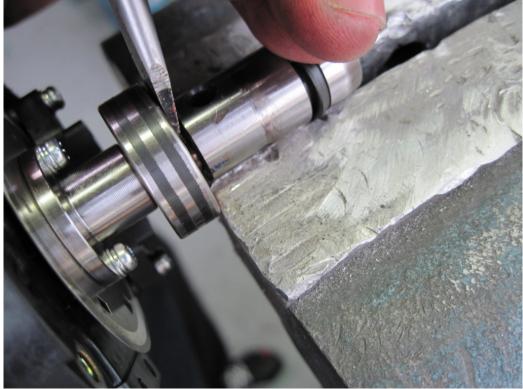
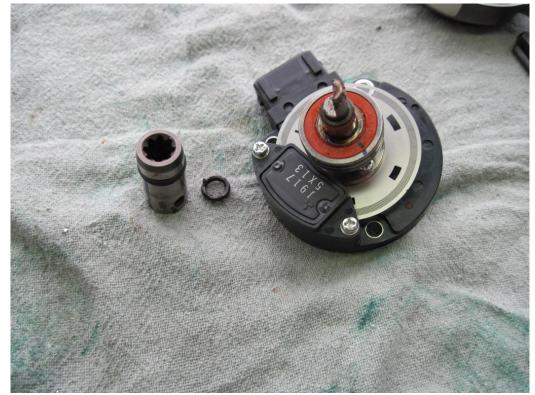
Figure 26: Removal of star socket using 1/4" flat screwdriver

Figure 27: Star socket removed from CAS sensor

Remove the star socket with a $\frac{1}{4}$ " flat screwdriver as shown in figure 26. Figure 27 shows the star socket removed with the small rubber seal that is inside it.

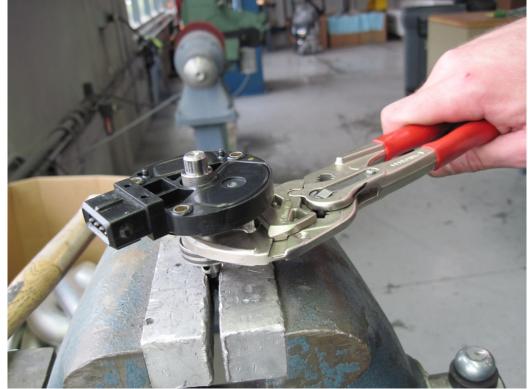
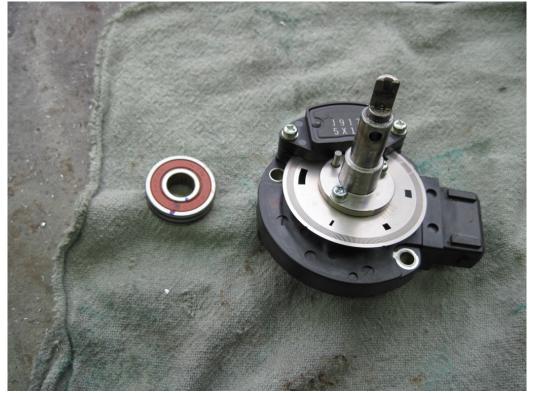
Figure 28: Removal of bearing from shaft using pliers

Figure 29: Bearing removed from shaft

This is another step that requires a little finesse or a friend. Remove the remaining bearing using a pair of pliers with flat jaws to have a firm grip on the shaft but be narrow enough to fit in between the collar on the shaft and the bearing. Hit the pliers with a mallet. Note how the shaft is placed into the vise in figure 28. Figure 29 shows

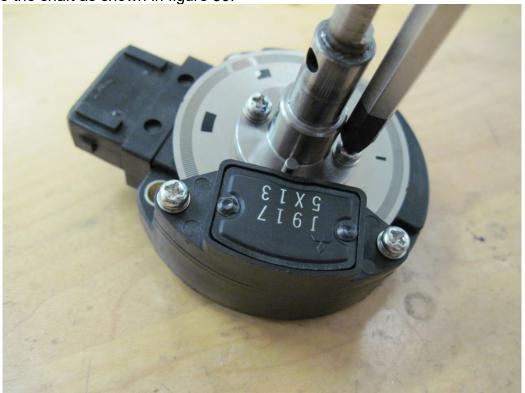
Figure 30: Removal of 2 screws on CAS disc using number 2 Phillips screwdriver

Using the number 2 Phillips screwdriver remove the screws holding the CAS disc onto the shaft as shown in figure 30.

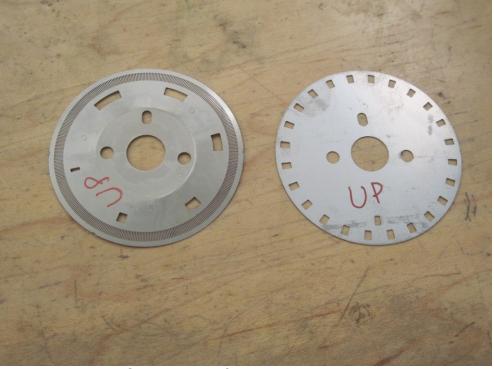
Figure 32: Comparison of original and AEM trigger discs

The original and AEM trigger discs must be aligned in the correct orientation since the locating pin is slightly offset as shown in figure 32.

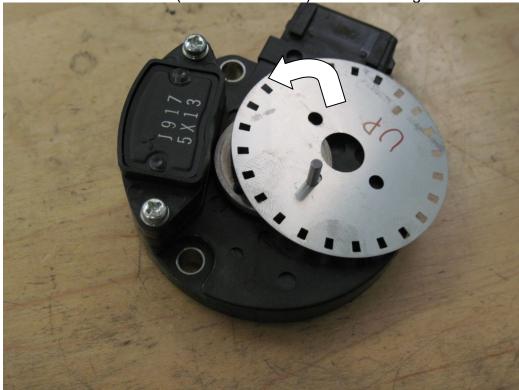
Figure 33: AEM trigger disc being installed

Install the AEM CAS sensor disc (AEM PN 35-8761) as shown in figure 33.

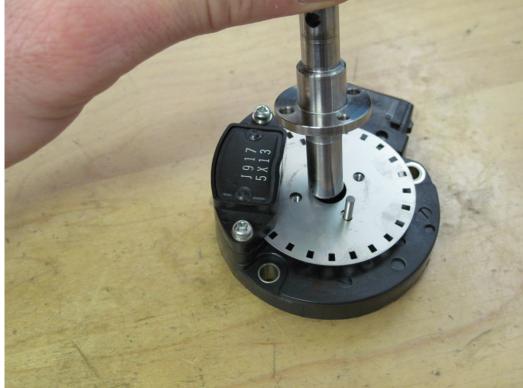
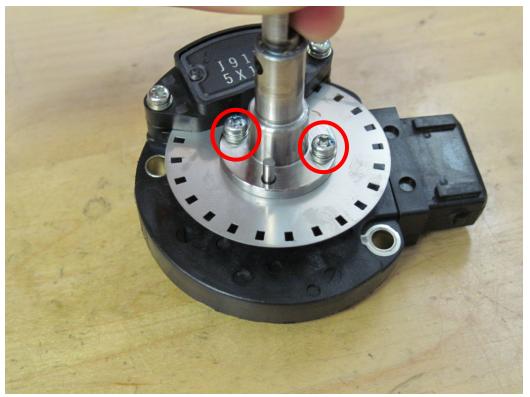
Figure 34: CAS sensor shaft reinstallation

Figure 35: Screws for CAS shaft replaced

Reinstall the shaft onto the CAS sensor as shown in figure 34 and replace the screws on the shaft with some thread locker as shown in figure 35.

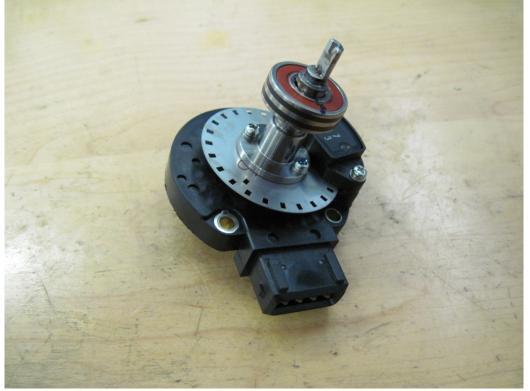
Figure 36: Bearing placement on CAS shaft

Figure 37: Hammering star socket to press on socket and bearing

Reinstall bearing as shown in figure 36. Next add some grease or spray lube onto the oring that came off of the star socket that goes over the bearing and lightly hammer the star socket on a flat surface so that you are only hammering the shaft until the hole for the pin that holds the star socket lines up as shown in figure 37. A pin punch can be used to align the hole for the pin if it is slightly off.

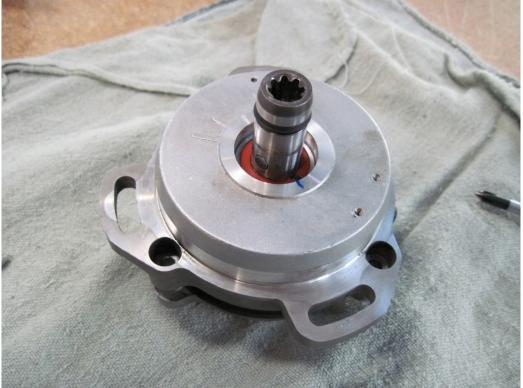
Figure 41: Housing cover reinstalled

Reinstall 2nd CAS housing half making sure that the plastic connector and rubber seal are aligned properly to avoid CAS sensor and disc damage. The housing should be able to be pressed on by hand with even pressure around the whole assembly. Once together,

reinstall screws with threadlocker. See figure 41.

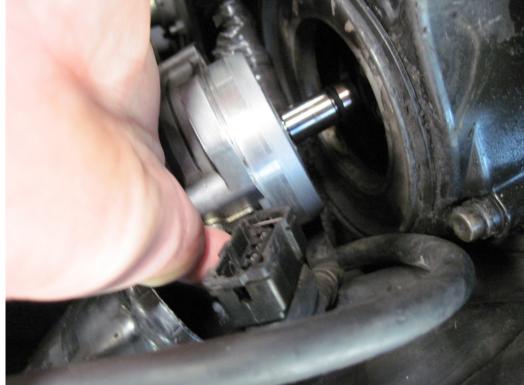
Figure 43: Reinstalling the CAS sensor

Align the CAS sensor with the mark you made at the beginning of the instructions or alternatively, look at the cam and align the sensor with the groove in the cam. Make sure

that the sensor is seated properly before reinstalling the bolts. See figure 43.

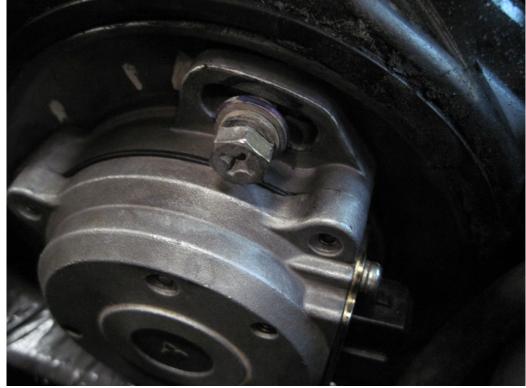
Figure 44: Reinstalling CAS sensor bolts

Align bolts with previously made markings and tighten as shown in figure 44.

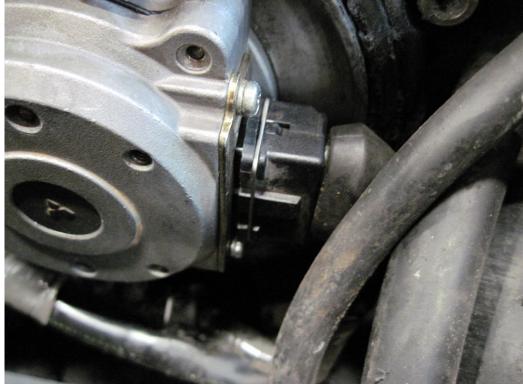
Figure 45: Replacing CAS sensor connector

Reattach the plastic connector to the CAS sensor after making sure the metal retaining clip is present and installed correctly. See figure 45.
